TECHIMP HV TRANSFORMER CASE STUDIES

On-line PD detected inside the bushing

Global Condition Monitoring System for Power Transformer

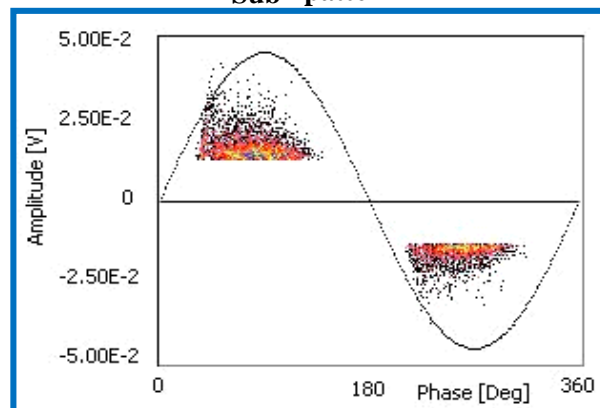
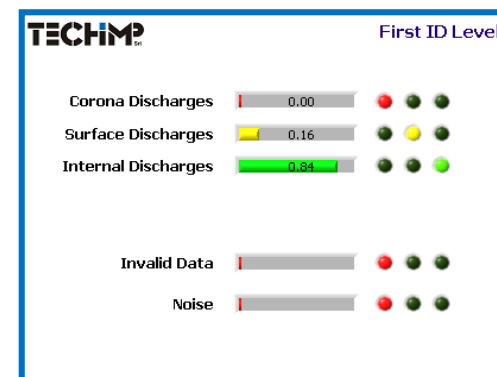
PD Activity

Acquisitions from phase 8 : 4 different phenomena

Test results:

internal/surface discharge occurring on paper surface and interface cavities of bushing of phase 8.

Red phenomenon PD activity
Sub pattern

.... Customer's decision: to replace bushing

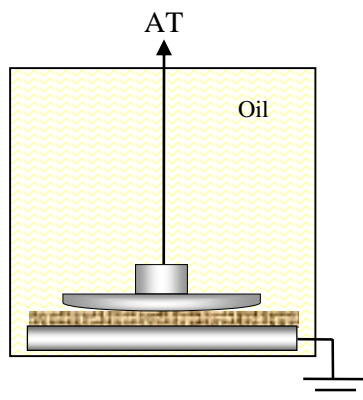
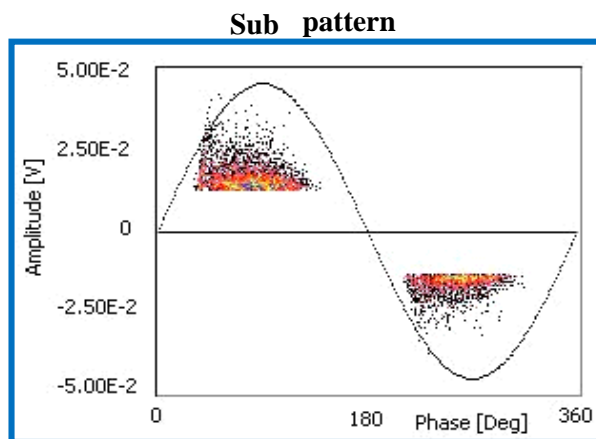
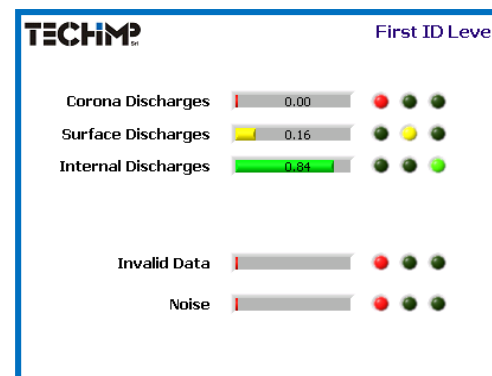
On field measurement

Red phenomenon

PD activity

Rogowski electrode
on pressboard

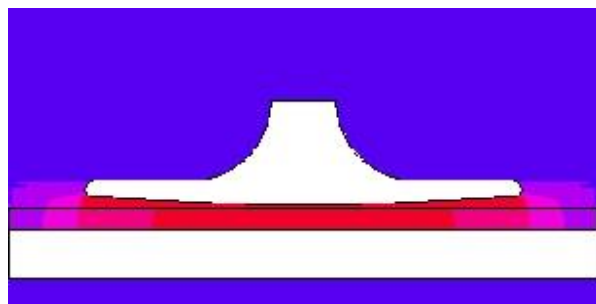
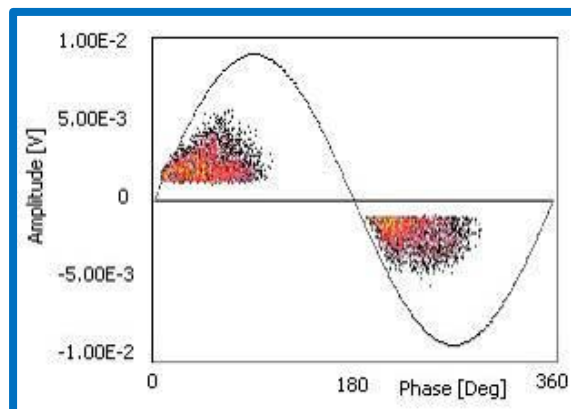
Laboratory measurement

Pressboard
internal discharges

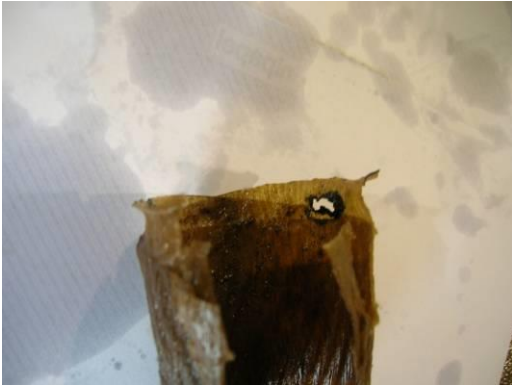
Degradated oil/paper insulation

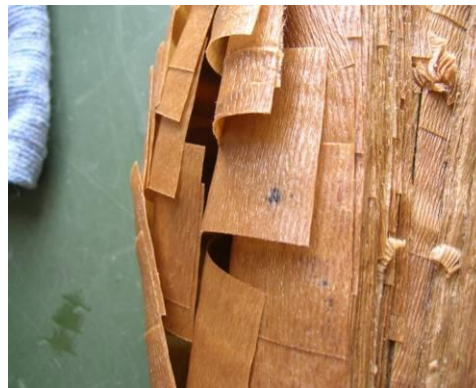
Degradated oil/paper insulation

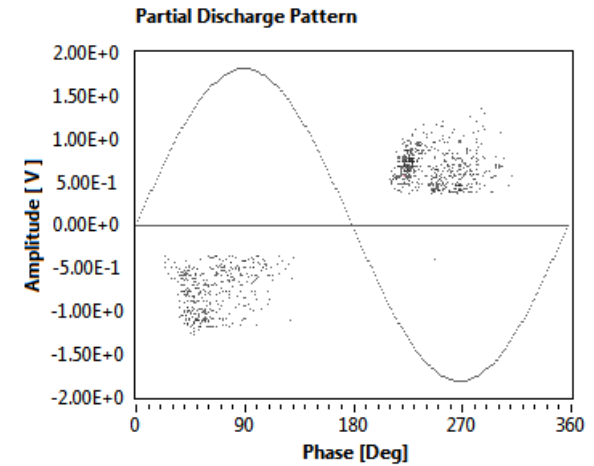
A sporadic activity due to small **GAS BUBBLES** in the oil not yet harmful. This activity was intermittent and detected few times in a month. The probability of triggering such activities increases significantly installing PERMANENT monitoring systems.

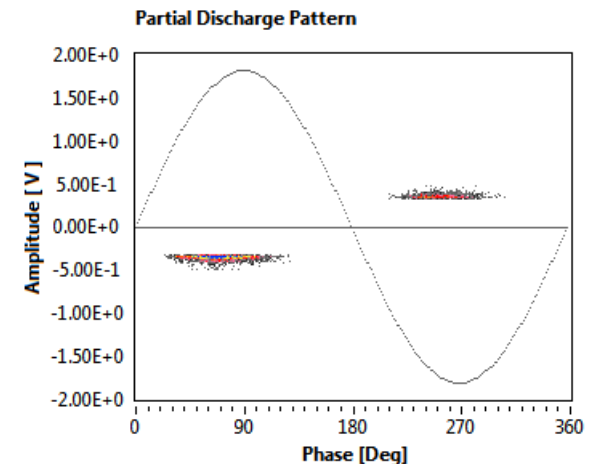
A strong activity with very high amplitude and repetition rate was detected in all the HV phases. This activity was identified as **INTERFACE PD**.

INTERFACE PD: discharges due to the high electric field gradient in correspondence of the junction of two different insulation materials (example in the transformer air/oil o oil/paper).

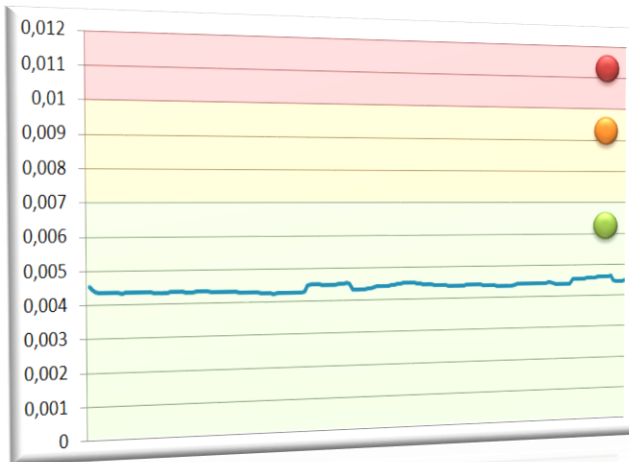
- No significant changes in bushing Tan- δ values were noted over the monitoring period (6 months) highlighting that there are **no problems inside the bushings**.
- The H₂ gas levels increased during the monitoring period with rates around 30 ppm/day highlighting that there is a problem **inside the transformer**.

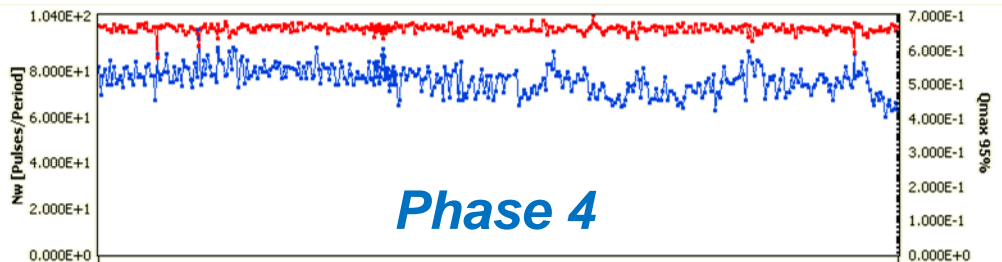
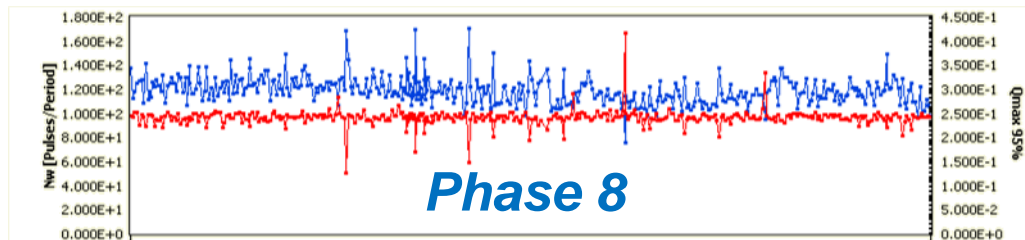
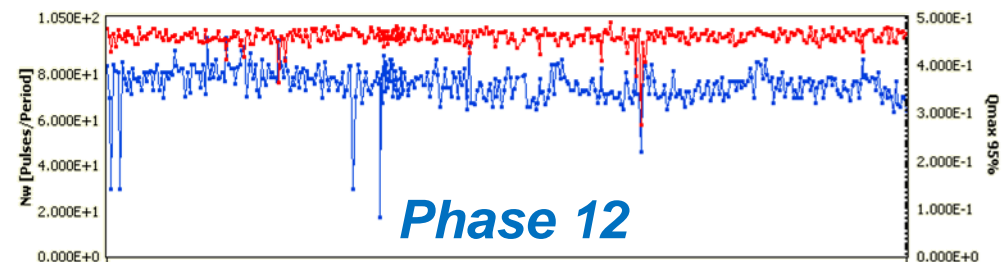
- PD activities were detected in correspondence of all the three HV phases, demonstrating that such phenomena (interface PD) were directly connected to the H2 gas increase.

- The PD pattern polarity and characteristics indicated clearly that the PD was located **into the transformer**; the very high frequency of the phenomenon has allowed us to locate the defect in the upper part of the transformer close to the bushings.
- The constant trend over time leads to the conclusion that the three defects are not harmful in the short term.
- The characteristics of the PD entirely comparable in all three phases, together with the location in the upper part of the transformer, have led to the conclusion that the problem was generated from an interface air / oil.

The presence of air in the upper part of the transformer has been attributed to the imperfect filling of oil in the three bushings, resulting in the creation of interface air / oil.

After all the tests, the transformer has been emptied and refilled with hot oil and degassed under vacuum, so as to avoid the formation of interfaces air / oil.

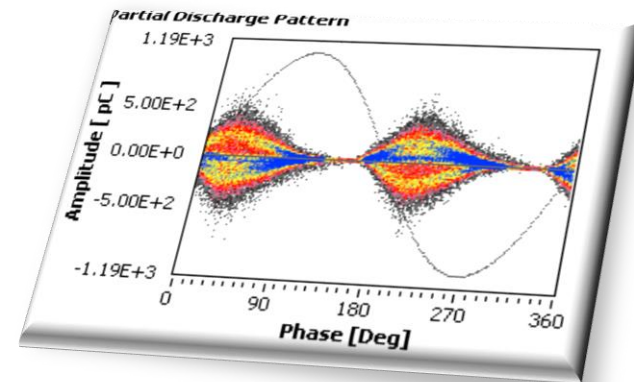
- ✓ Tan- δ of the bushings.
 - ✓ DGA of bushings oil.
 - ✓ PD TEST in both UWB and IEC bandwidth :
- The first two measurements were carried out in order to be 100% sure that the bushings were problem-free. *Techimp diagnosis confirmed.*
 - The third measurement was carried out because the utility wanted to be 100% sure that the PD detected by Techimp was not relevant to an external interference. *Techimp diagnosis confirmed : the Interface PD (filtered from noise and external disturbances) detected during the on-line monitoring were relevant to internal phenomena inside the transformer. Amplitude of the phenomenon is about 500pC and with Inception Voltage 60% Un.*

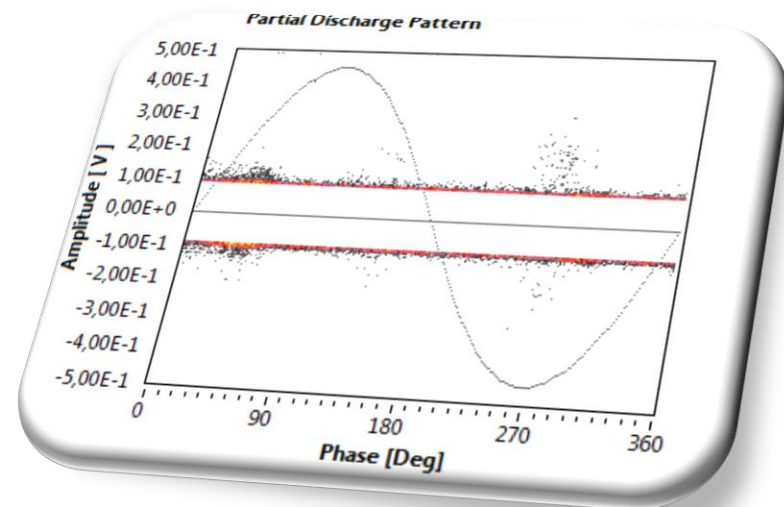
- The monitoring period following this treatment has **CONFIRMED THE ELIMINATION OF THE DEFECT ON ALL THREE PHASES.**
