TECHIMP **HV GIS** CASE STUDIES

LIST OF CASE STUDIES

CASE STUDY

On-line PD detected inside the dielectric spacers of GIS terminations.

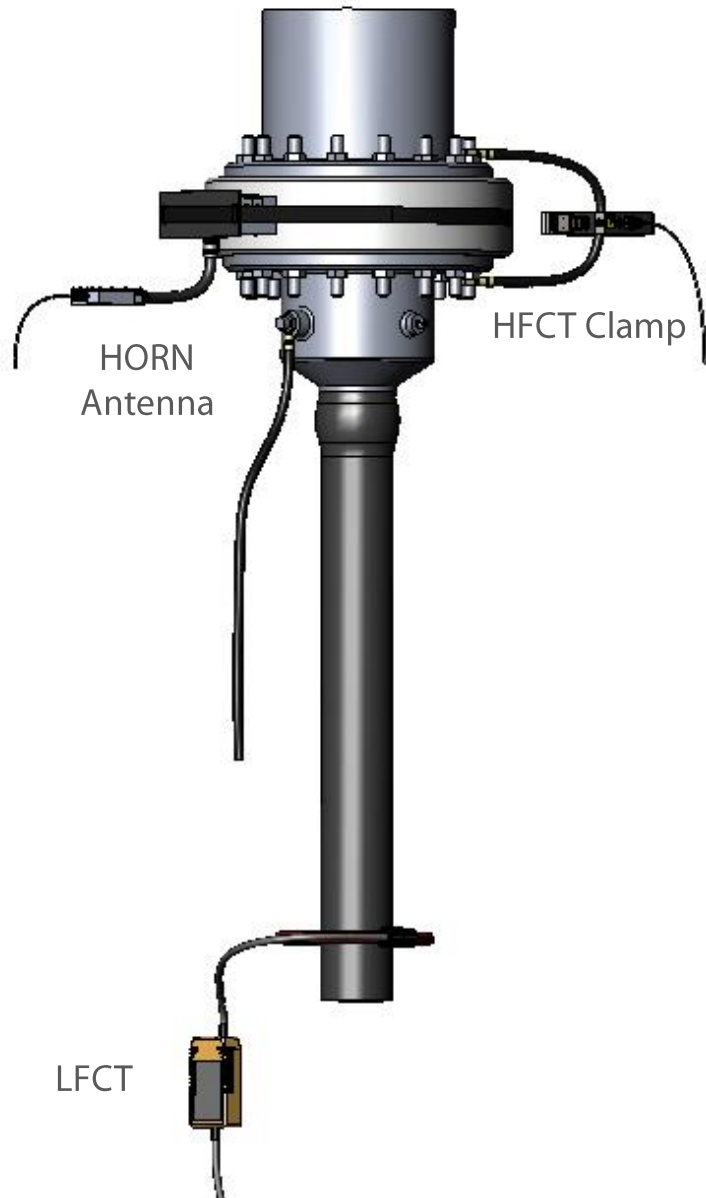
[GIS Termination]

High Frequency PD pulses were achieved by means of Clamp HFCT 39mm placed around the ground connection, and by means of HORN Antenna placed on dielectric spacer of the GIS Termination.

Thanks to the Clamp version of the HFCT it is possible to perform on-line PD measurements without ground lead disconnection or out of service of the EUT.

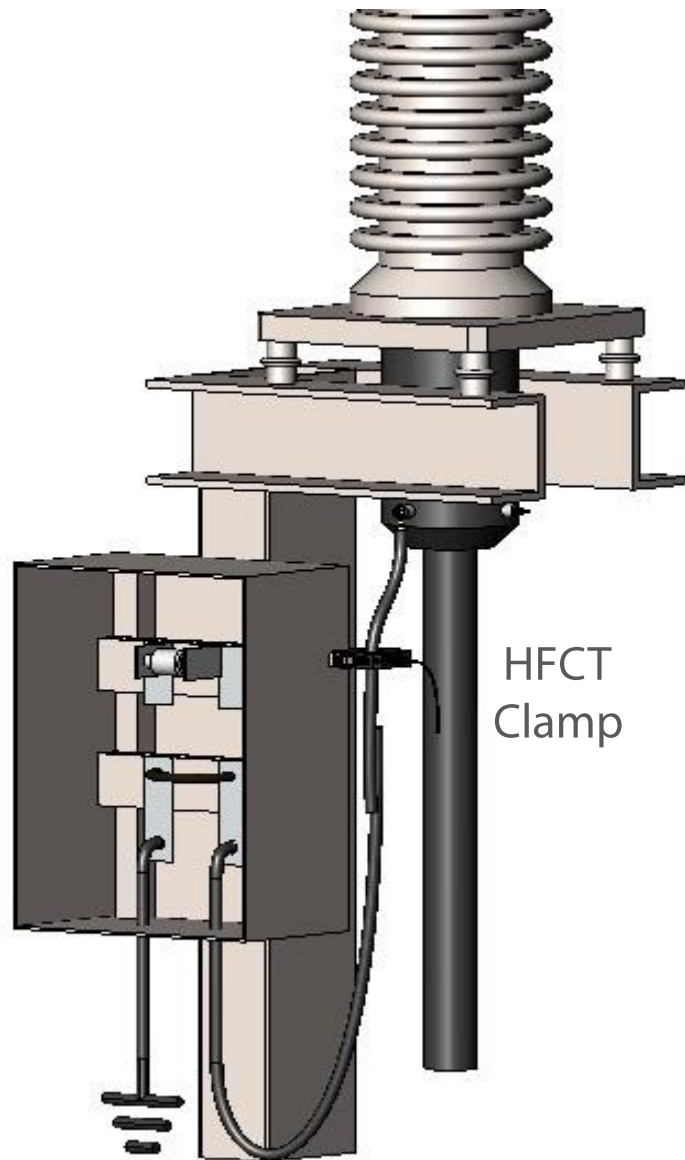
[ODSE Termination]

High Frequency PD pulses were achieved by means of Clamp HFCT 39mm placed around the ground connection of the ODSE Termination.

Thanks to the Clamp version of the HFCT it is possible to perform on-line PD measurements without ground lead disconnection or out of service of the EUT.

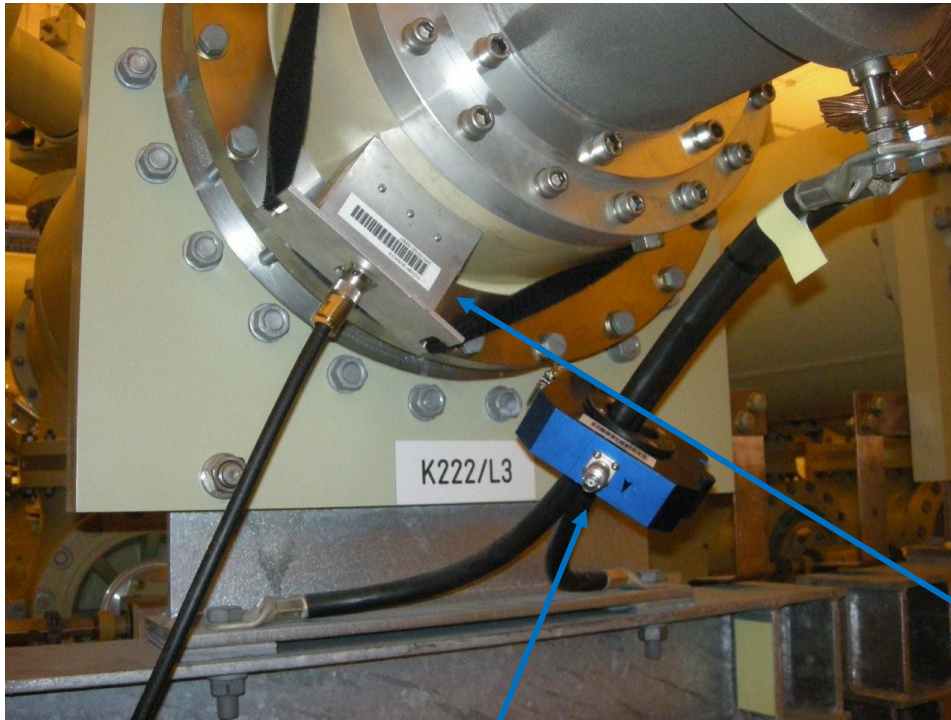
HFCT sensor around
cable ground lead

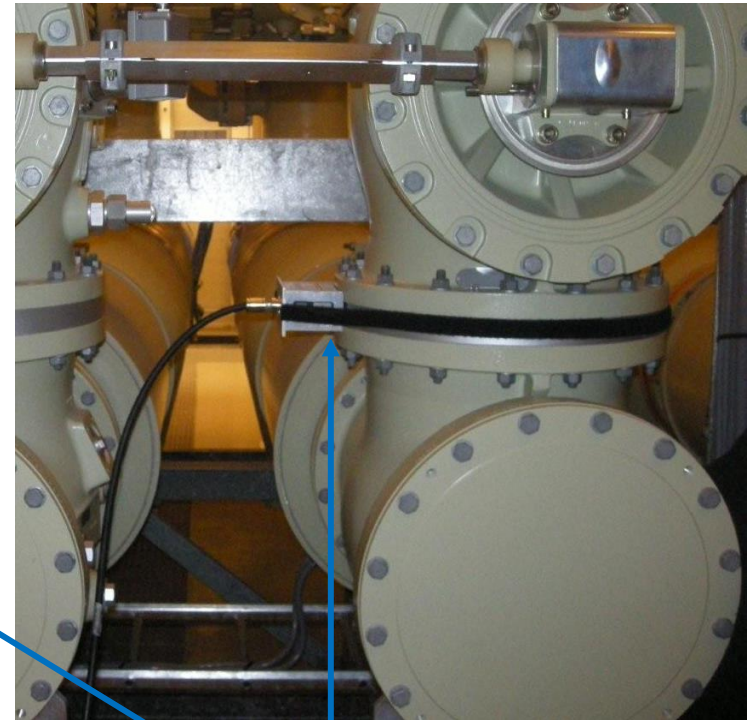
UHF antenna on GIS
spacer

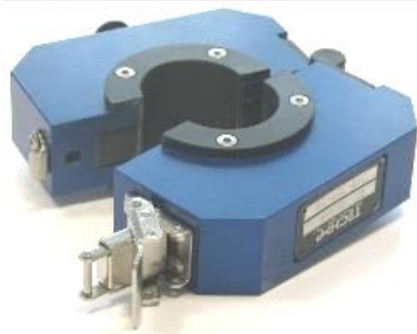
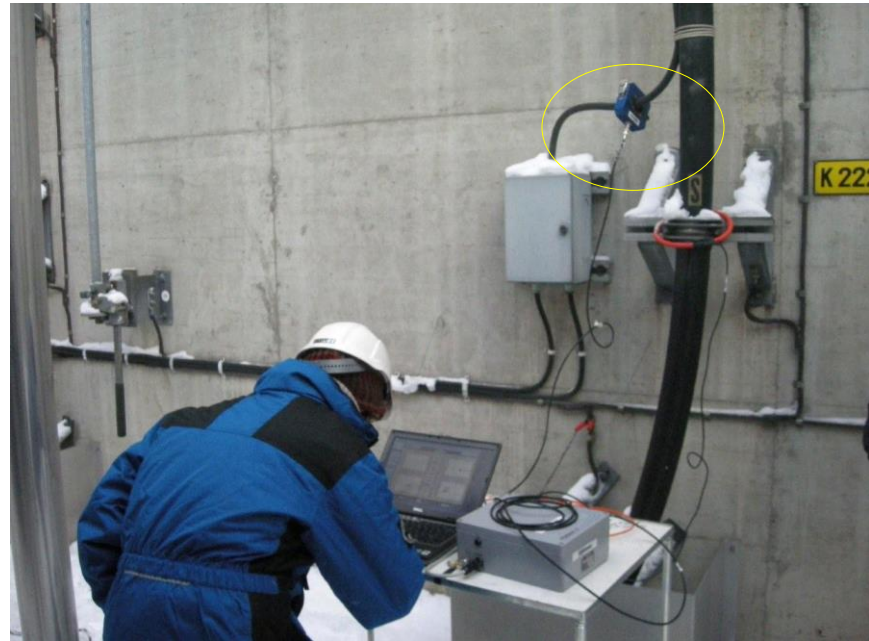
HFCT inductive sensor and its installation
around the ground lead at cable termination

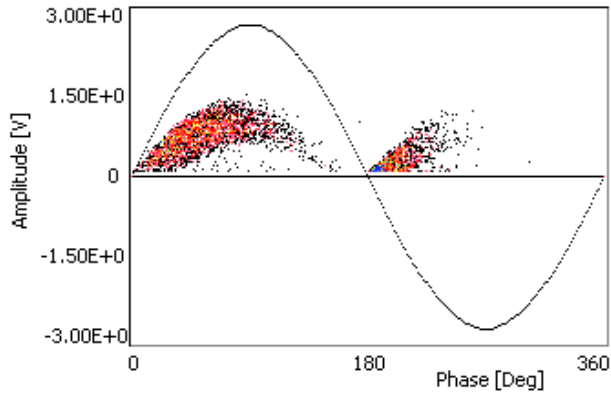
Internal PD detected with UHF Antenna.
The internal PD was located in the dielectric
spacers at GIS termination
(CORRECT ALARM !)

Considering amplitude and repetition rate of detected PD it has been suggested to:

1 – Monitoring the PD amplitude Trend

in order to verify that PD activity in the GIS does not increase too quickly. In this way the customer may schedule **maintenance only when really needed**.

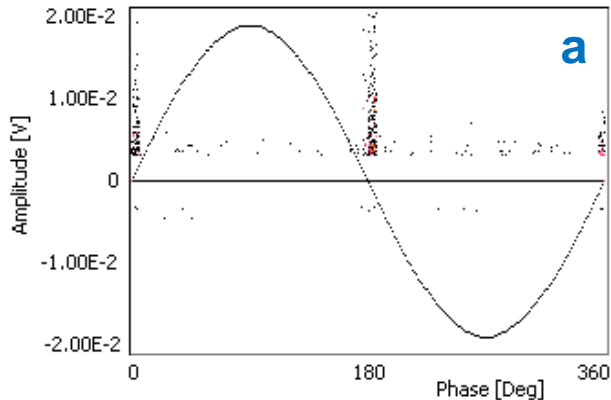
a) PD activity detected inside the GIS
PD measurement only on the GIS does not
allow an exhaustive analysis of the detected
phenomena
(FALSE ALARM !)

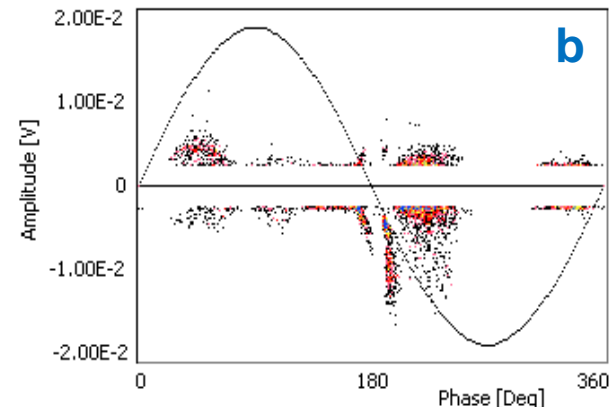
b) PD activity detected at Outdoor Termination
Carrying out PD detection also at the outdoor
termination the PD activity can be correctly addressed
to an external Phenomena

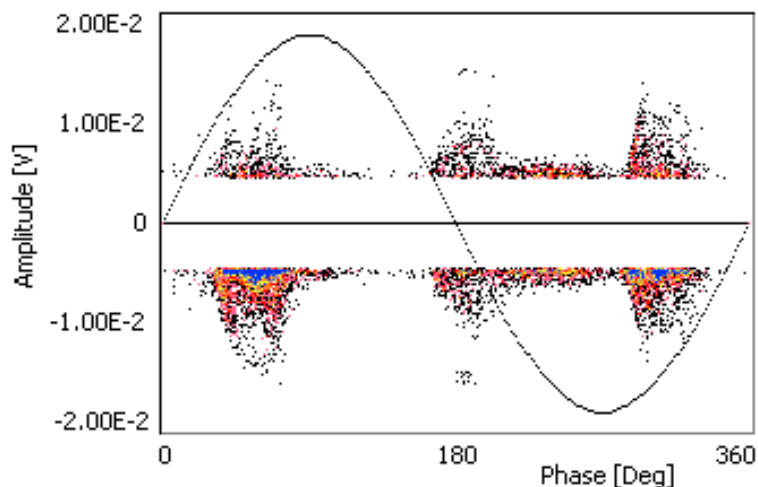
PRPD Pattern – Sub class A
Surface and corona disturbances
at outdoor bushings

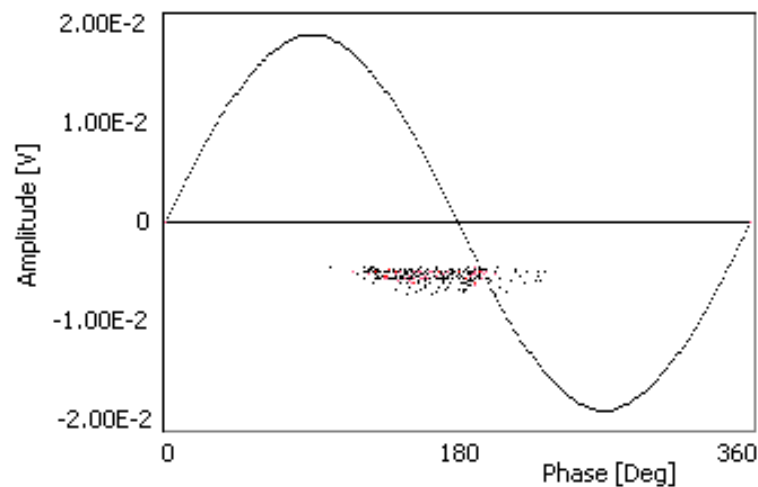
PRPD Pattern – Sub class B
PD due to internal cavity

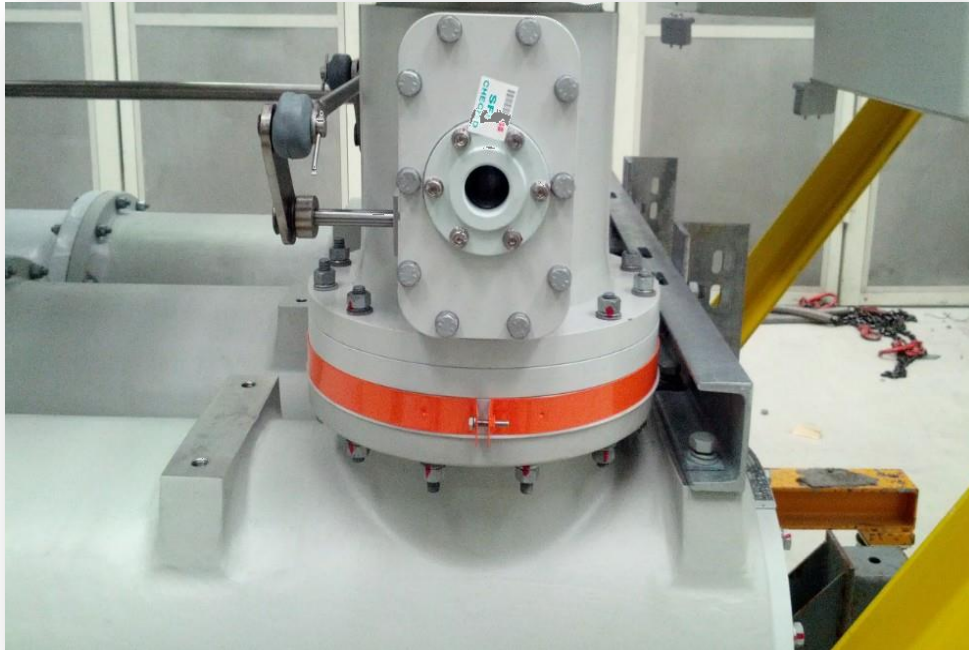
[GIS Switch]

High Frequency PD pulses were achieved by means of Clamp HFCT 39mm placed around the ground connection, the HORN Antenna placed on dielectric spacer of the GIS Termination and by means the window coupler covering the dielectric inspection window.

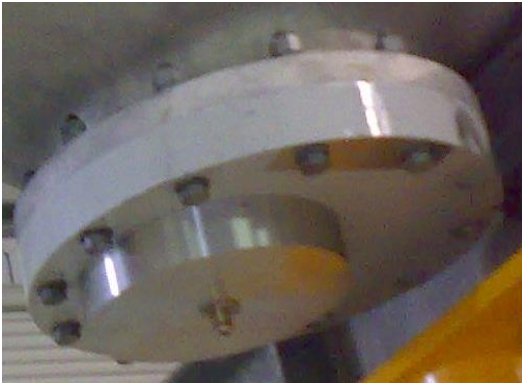
Window coupler covering the dielectric inspection window

When GIS are provided with dielectric inspection windows, PD detection in UHF bandwidth can be obtained using circular window external couplers, which represent robust and effective alternative to the use of internal sensors.

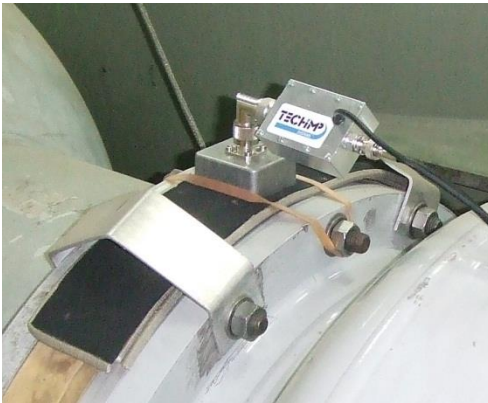
Spacer coupler applied to the dielectric spacer

Discharges due to the presence of protrusions, floating particles and internal defects in the dielectric spacer can be successfully detected placing UHF sensors attached to the spacer.

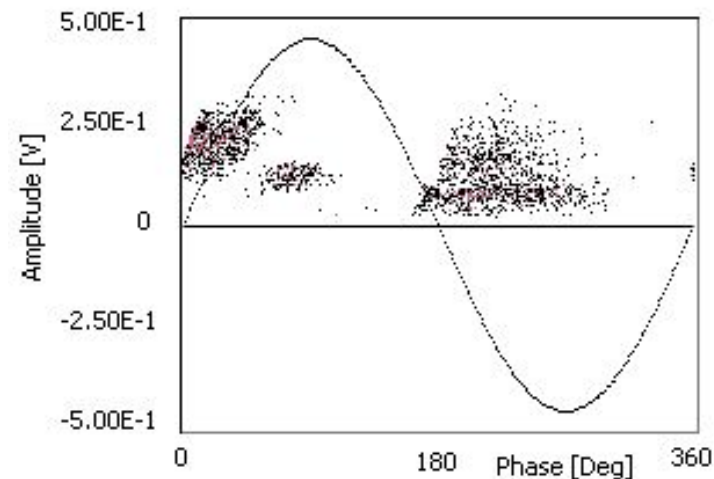
170 kV

The detected PD was a manufacturing defect due to bad assembly.

In order to avoid this kind of problem it is suggested to use

Techimp solutions for FAT:

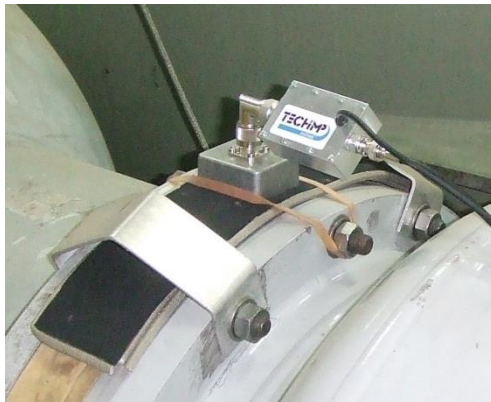
During the measurement 3 external PD sensors were used, located on the spacers of the bus duct.

Spacer coupler

applied to the dielectric spacer

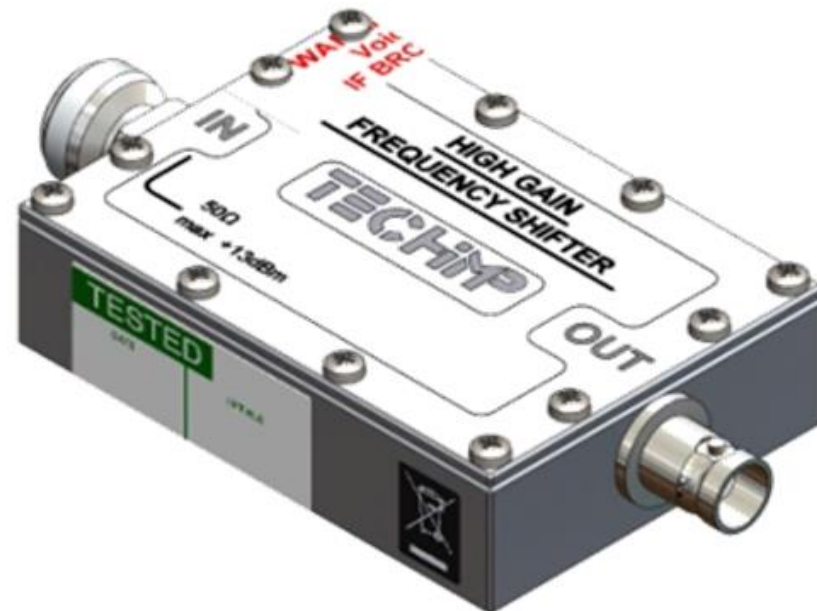
Frequency shifter

- Band pass filter BP: 150 MHz – 1 GHz
- Gain: +40dB
- External power supply or internal battery: 9 V
- Input connector: UHF N male
- Output connector: BNC female

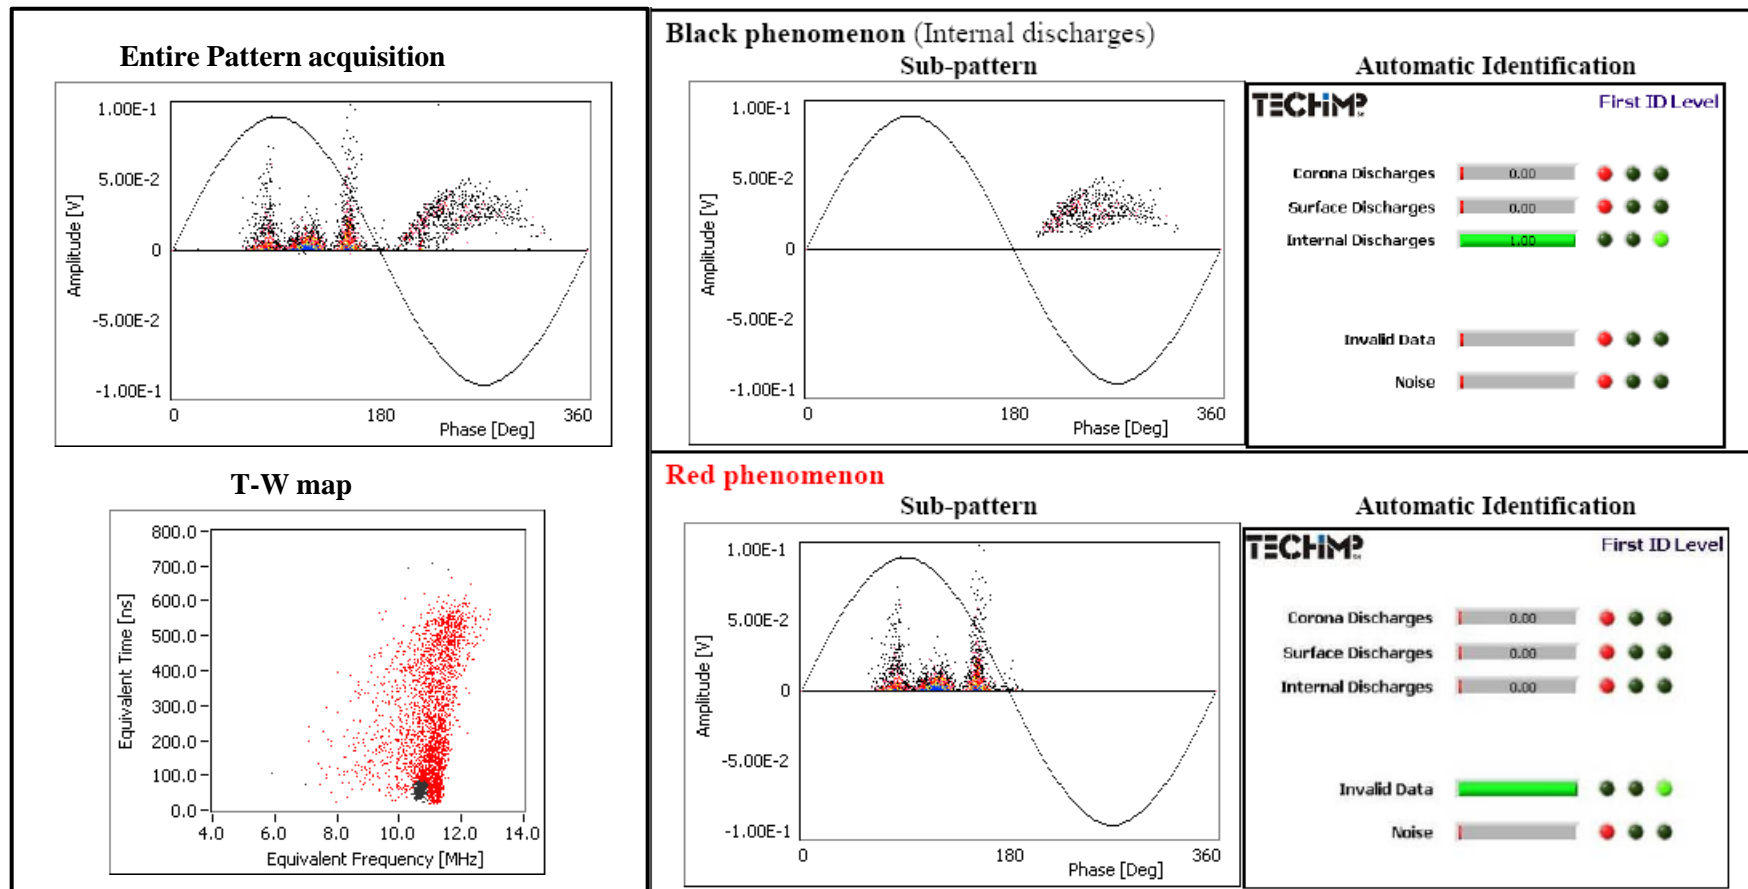
Internal PD were detected from only one sensor. Strong selectivity and attenuation along the GIS systems.

Regular basis PD Measurements

in order to do a frequent check of the entire GIS system.
