TECHIMP MV TRANSFORMER CASE STUDIES

LIST OF CASE STUDIES

- ▣ 0,4/15 kV MV Transformer – Off-line PD Test
- ▣ 0,4/15 kV MV Transformer – On-line PD Test

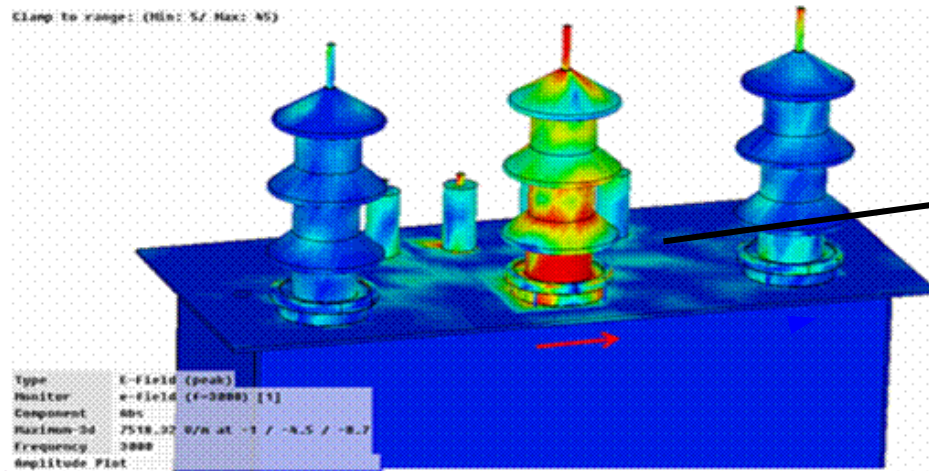
IRRADIATION

Antenna
Sensors

- ▣ **HFCT:** installed around cable ground lead or directly around cables. Monitoring of PD activities within both transformers and cables.
- ▣ **FMC:** tied to the cable. Monitoring of PD activities within both transformers and cables
- ▣ **UHF Antenna sensor:** close to cables entrance on the transformer top. Monitoring of PD activities within cable termination and inside transformer

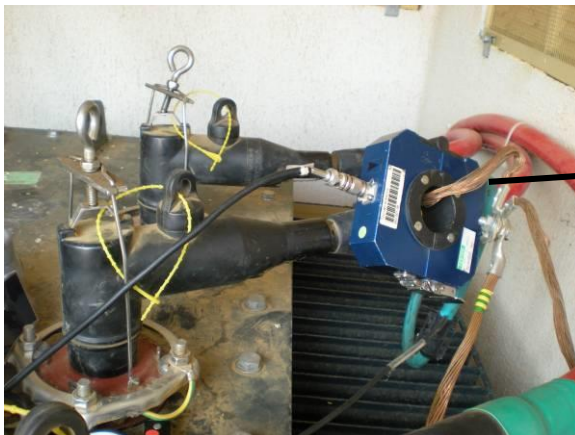
CONDUCTION

HFCT or
FMC on
MV cables

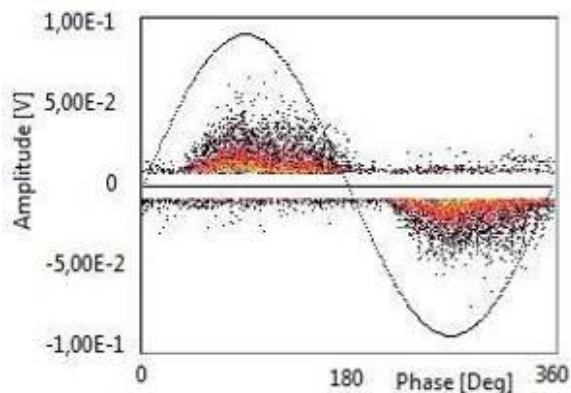
Acquisition through capacitive coupler:

- No Amplifier

PD Magnitude

- 50 mV

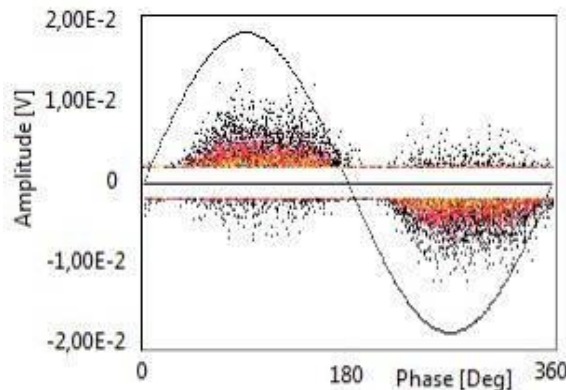
Acquisition through TEV Jumper:

- No amplifier

PD Magnitude

- 10 mV

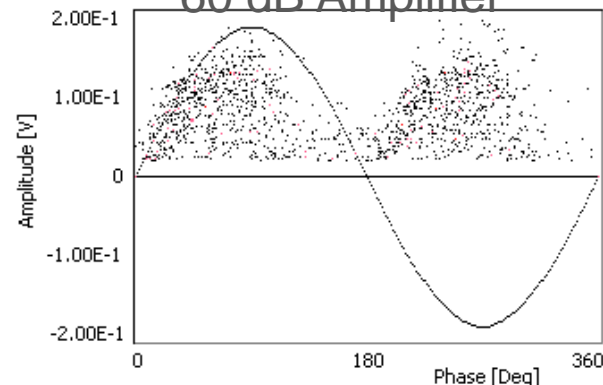
Acquisition through HORN antenna:

- HP 300 MHz and 60 dB Amplifier

PD Magnitude

- 150 mV

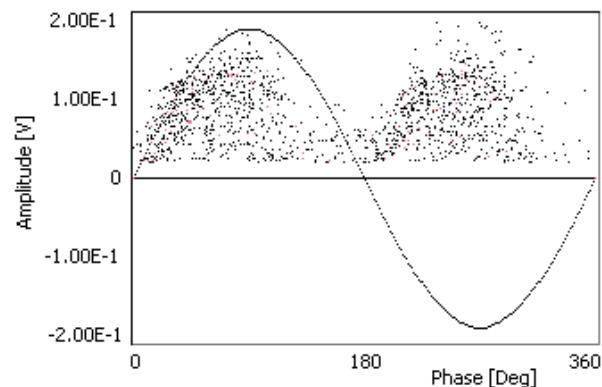
**SubPattern A:** Internal Defect relevant to Phase A

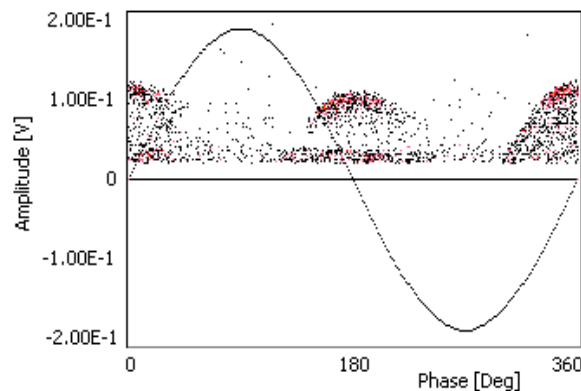
**SubPattern B:** Internal Defect relevant to Phase B

Detection
carried out
through Horn
Antenna sensor

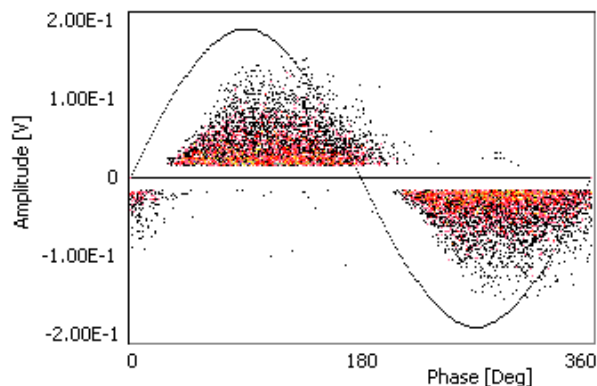
Acquisition through capacitive coupler:

- No Amplifier

PD Magnitude

- 150 mV

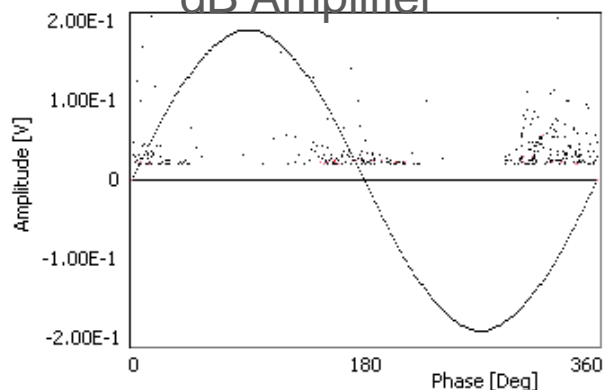
Acquisition through TEM Antenna:

- HP 100 MHz 20 dB Amplifier

PD Magnitude

- 100 mV

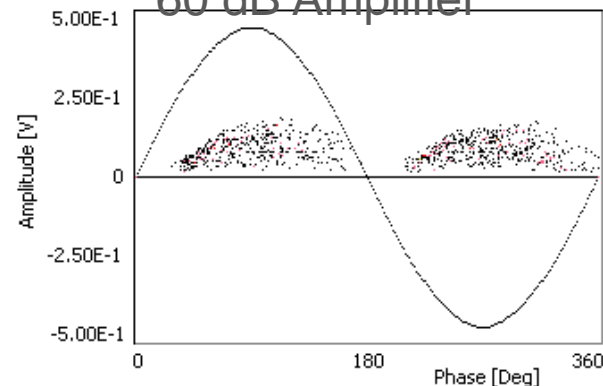
Acquisition through HORN antenna:

- HP 300 MHz and 60 dB Amplifier

PD Magnitude

- 200 mV

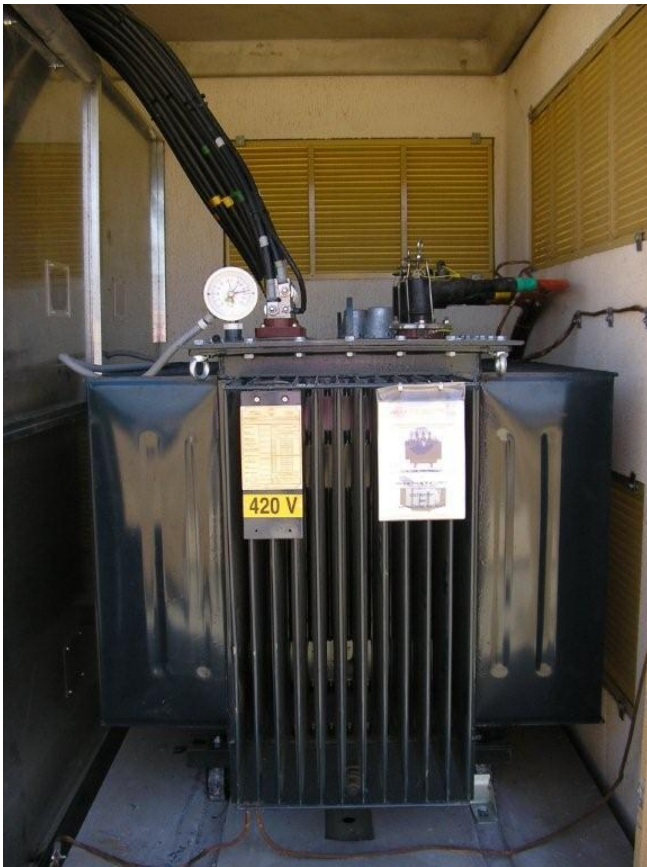
Transformer just after
installation

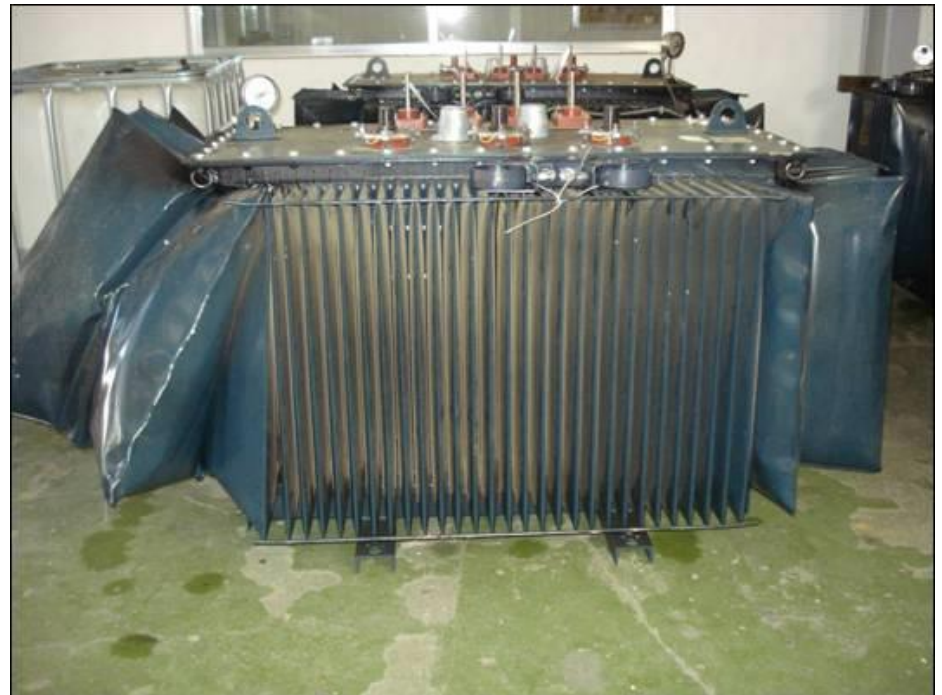
- ▣ In this solar plant 5 transformers EXPLODED in 5 months causing significant lost of money and time
- ▣ PD tests were carried out after these EXPLOSION both on-field and in factory: PD having very high magnitude were found in several units, preventing further unavoidable failures
- ▣ After-laying tests are, in general, avoided for costs reasons
- ▣ Using the SAME detector for ALL the assets of a solar park can be reasonable, economically viable and effective.
- ▣ It is enough to provide the transformers/cables and switchgears with appropriate sensors and to perform a periodical on-line screening.

Transformer after the
failure

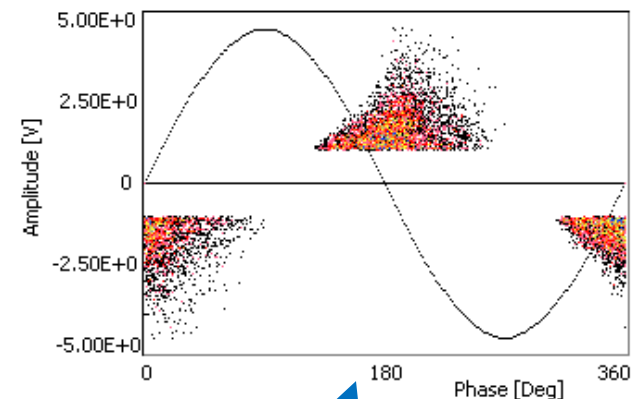
Interfaces PD in Phase Red

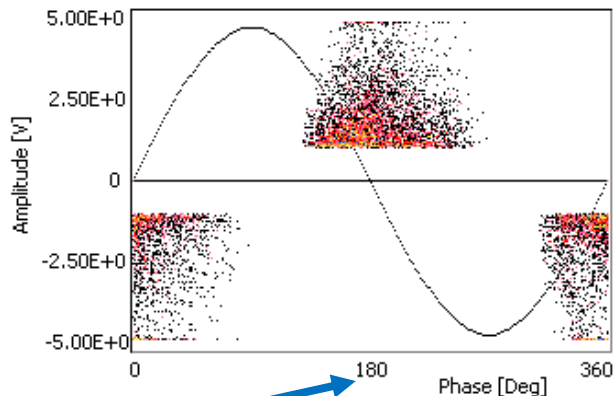
Interfaces PD in Phase Yellow

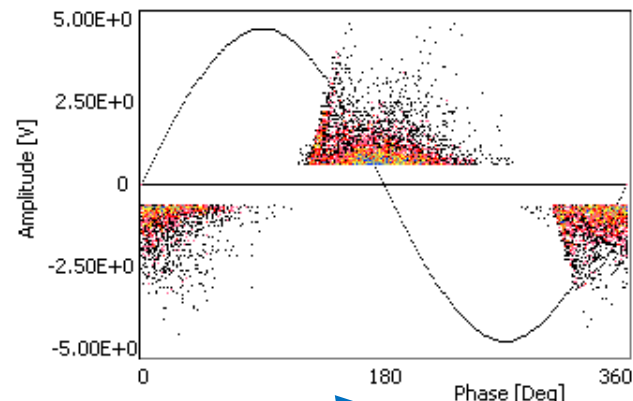
Interfaces PD in Phase Green

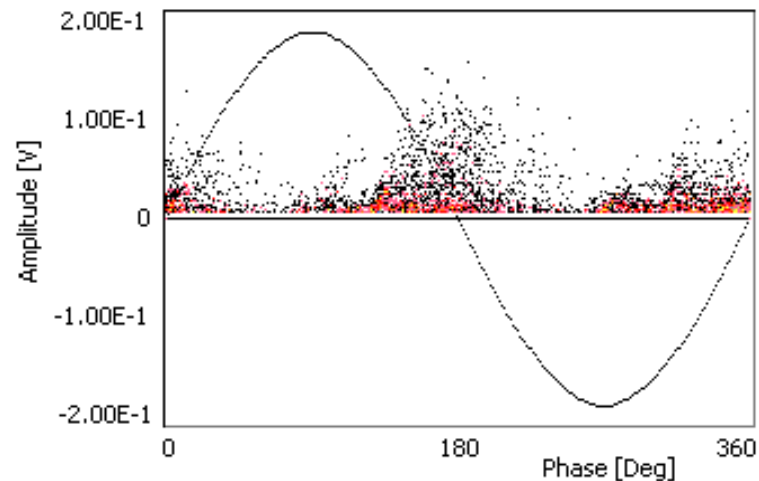
UHF Antenna close to the transformer bushing

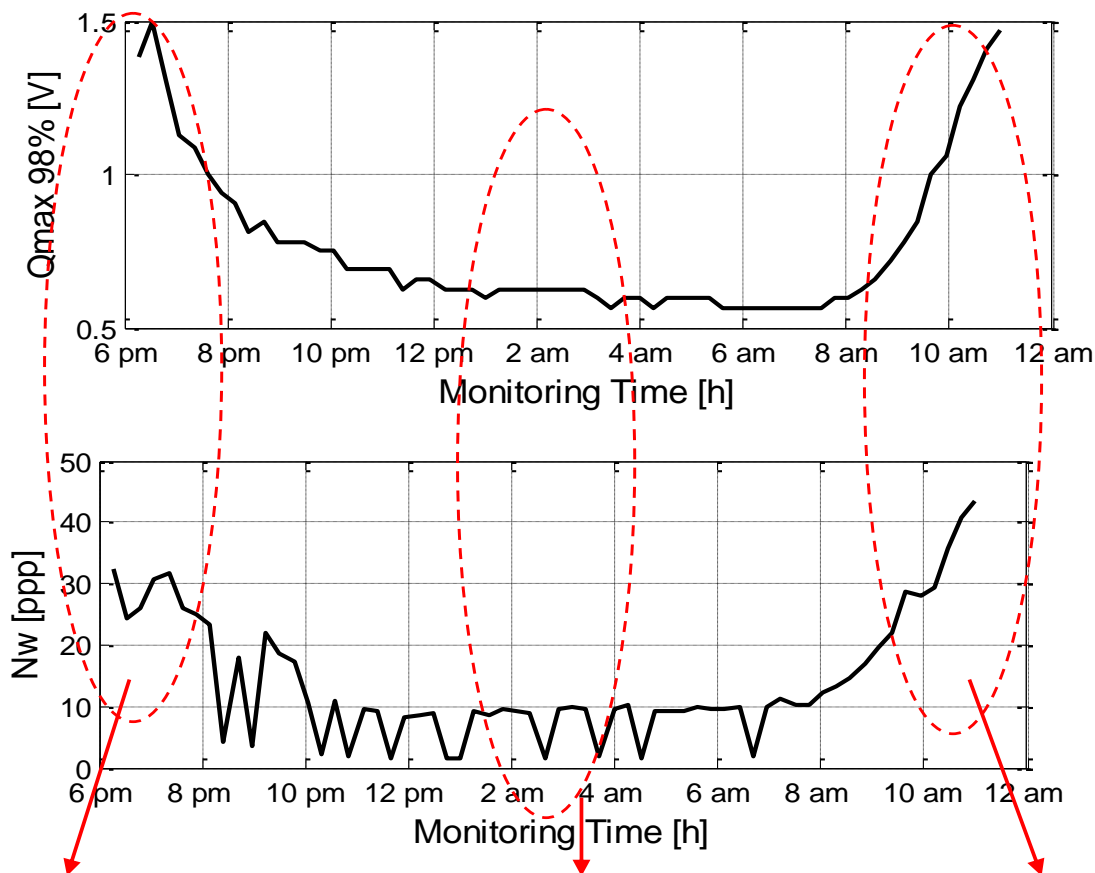
Same transformer was continuously monitored for 18 hours.

By analyzing the magnitude and repetition rate TREND it is possible to assess the risk associated to the PD activities and, thus,

PREVENT THE FAILURE!!
