TECHIMP **MONITORING** CASE STUDIES

Off-line PD detected in Power Plant

On-line PD detected in Power Plant

On-line PD Monitoring System in a Power Transformer

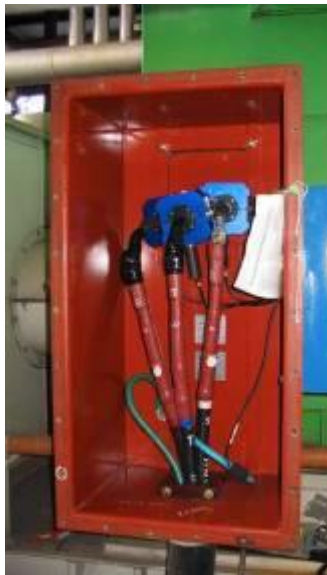
REFINERY: generators and motors under monitoring

SENSORS FOR MOTORS:

- 3 Couplers located inside motor terminal box, where room is enough,
- HFCT's around incoming MV cables.

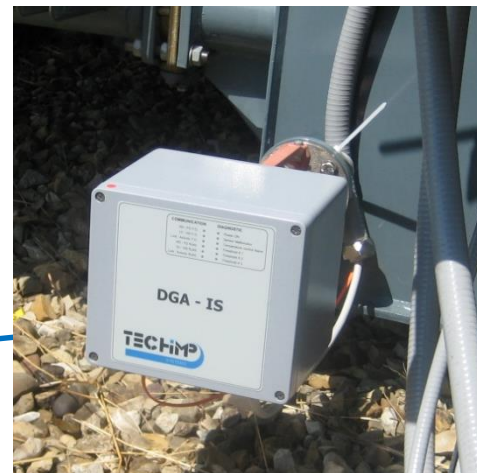
DGA Sensor

- Integrated DGA unit monitoring dissolved H₂ +CO and Moisture

After the installation of a big autotransformer, the utility started immediately to see a critical level of equivalent gas (using a 2 gas DGA unit)

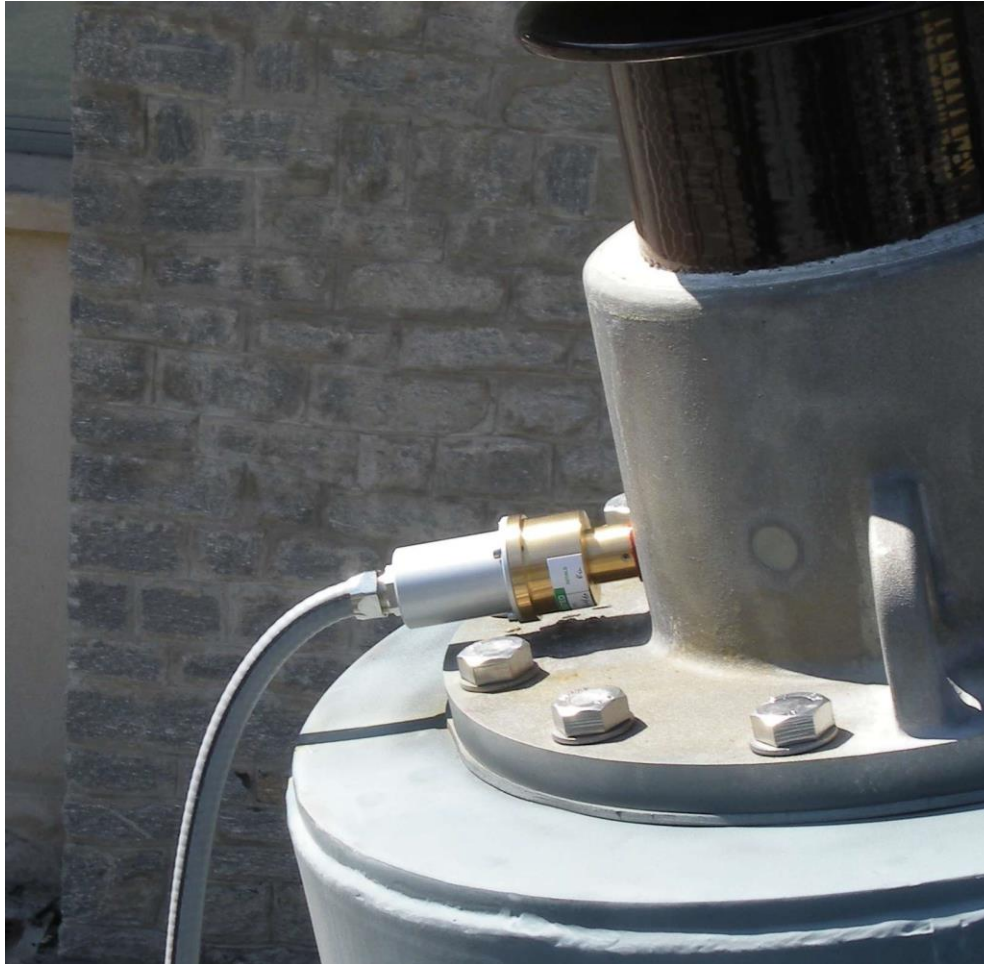
TAP ADAPTERS were installed in the 6 bushing capacitive taps

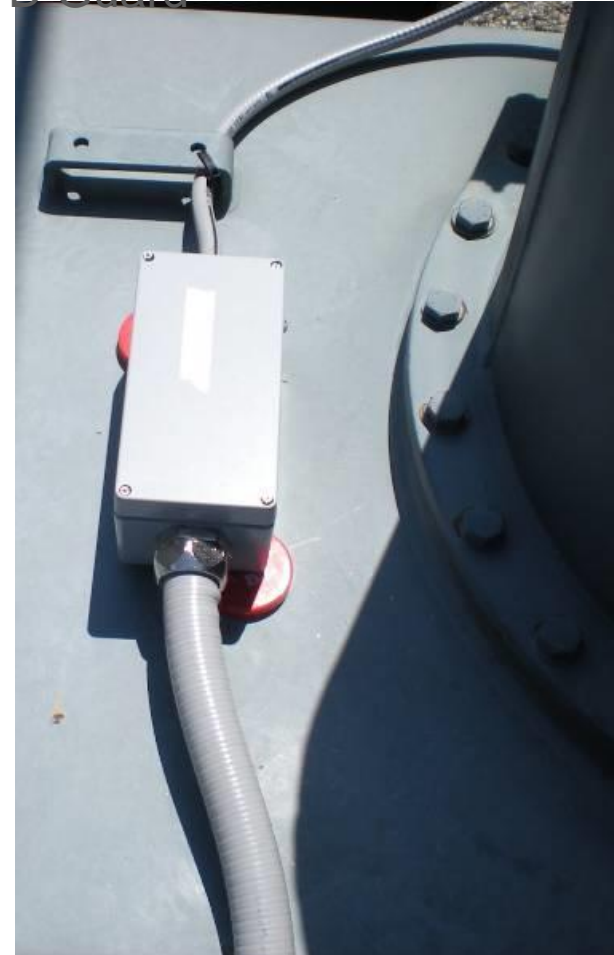
TD sensor was connected between the tap adapter and the TD Guard

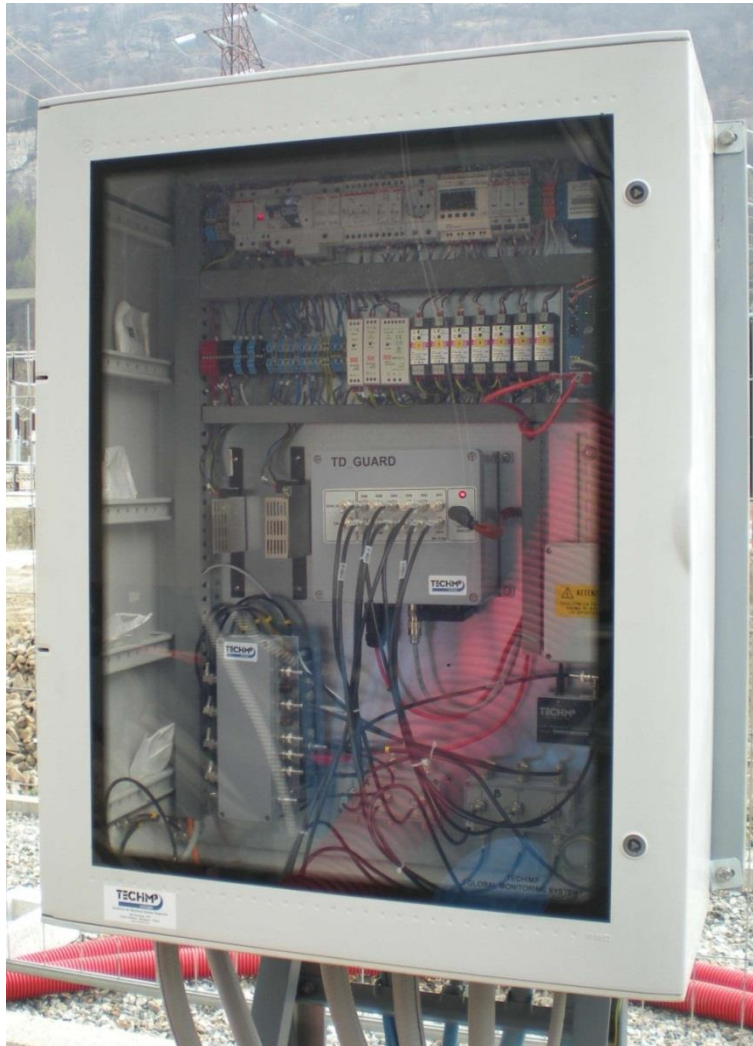
The acquisition Box was installed 2 meters far from the transformer

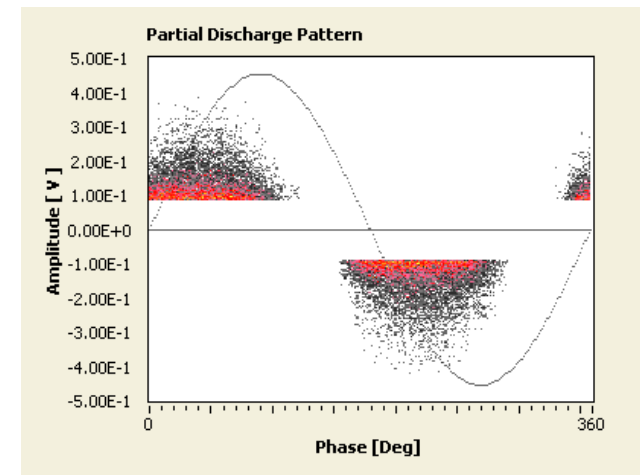
Oil treatment was carried out by the utility after 2 weeks from PDM system installation:

- ▢ The first activity, due to the bubbles, disappeared after the oil treatment.
- ▢ After the oil treatment, the second activity appeared again, immediately. The oil treatment did not cause any kind of change on such a phenomenon.
- ▢ Thus, the permanent PD monitoring was run in the transformer for a period of 6 months.
