TECHIMP HV TRANSFORMER CASE STUDIES

On-line PD detected inside the bushing

Global Condition Monitoring System for Power Transformer

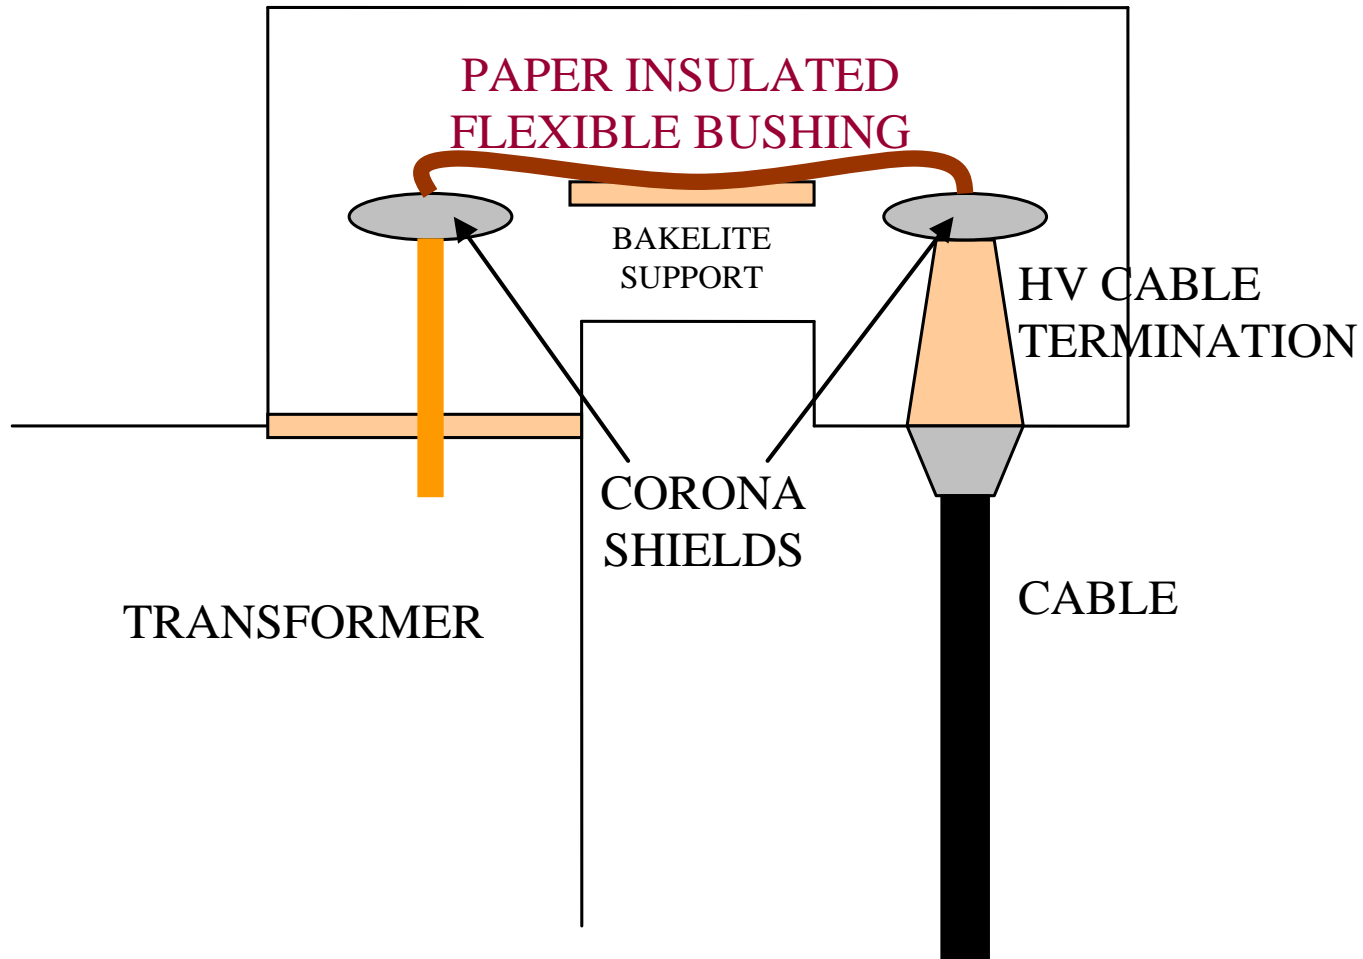
[GIS Termination]

High Frequency PD pulses were achieved by means of Clamp HFCT 39mm placed around the ground connection of the GIS Termination.

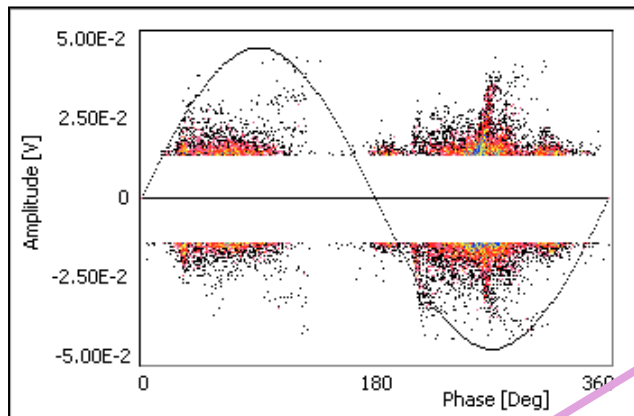
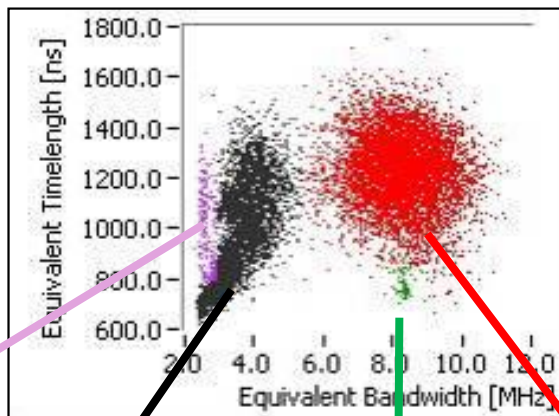
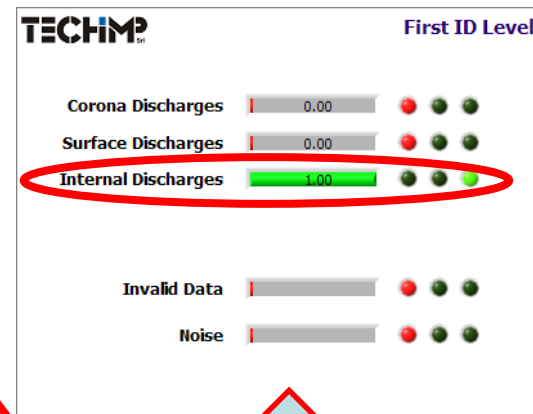
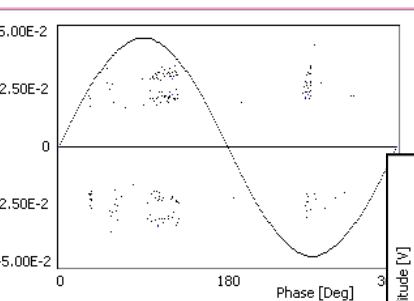
Phase 8

Acquisitions from phase 8 : 4 different phenomena

internal/surface discharge occurring on paper surface and interface cavities of bushing of phase 8.

.... Customer's decision: to replace bushing

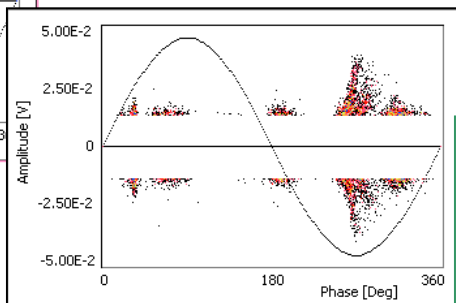
Voltage correlated disturbance

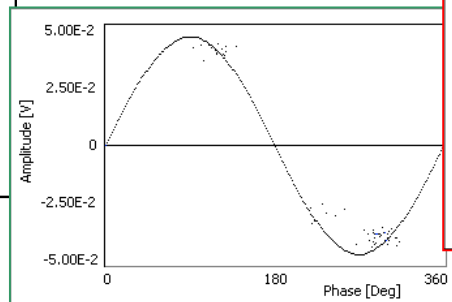
Three-phase corona

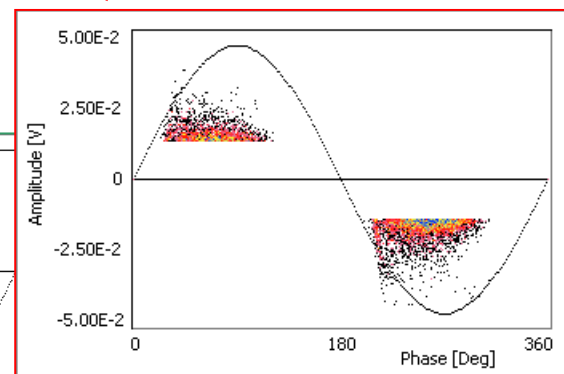
Cross talk phase 4

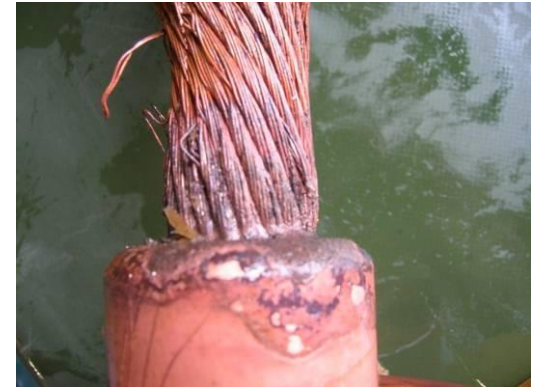
Degradated oil/paper insulation

HV Cable termination

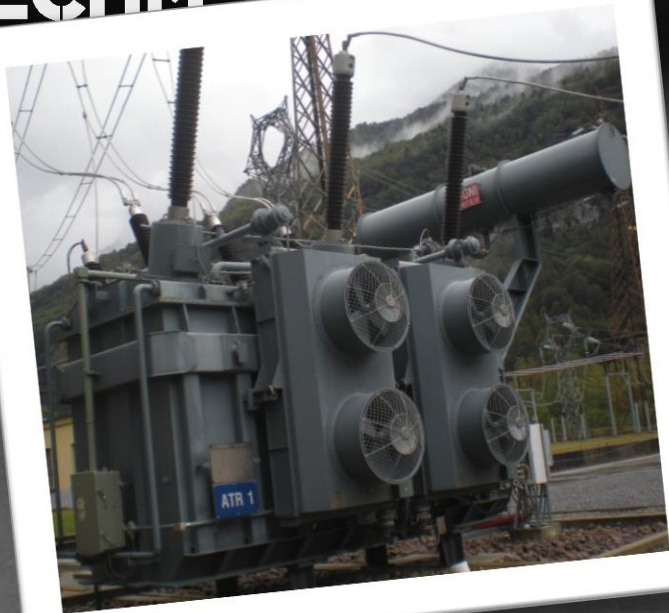
Degradated oil/paper insulation

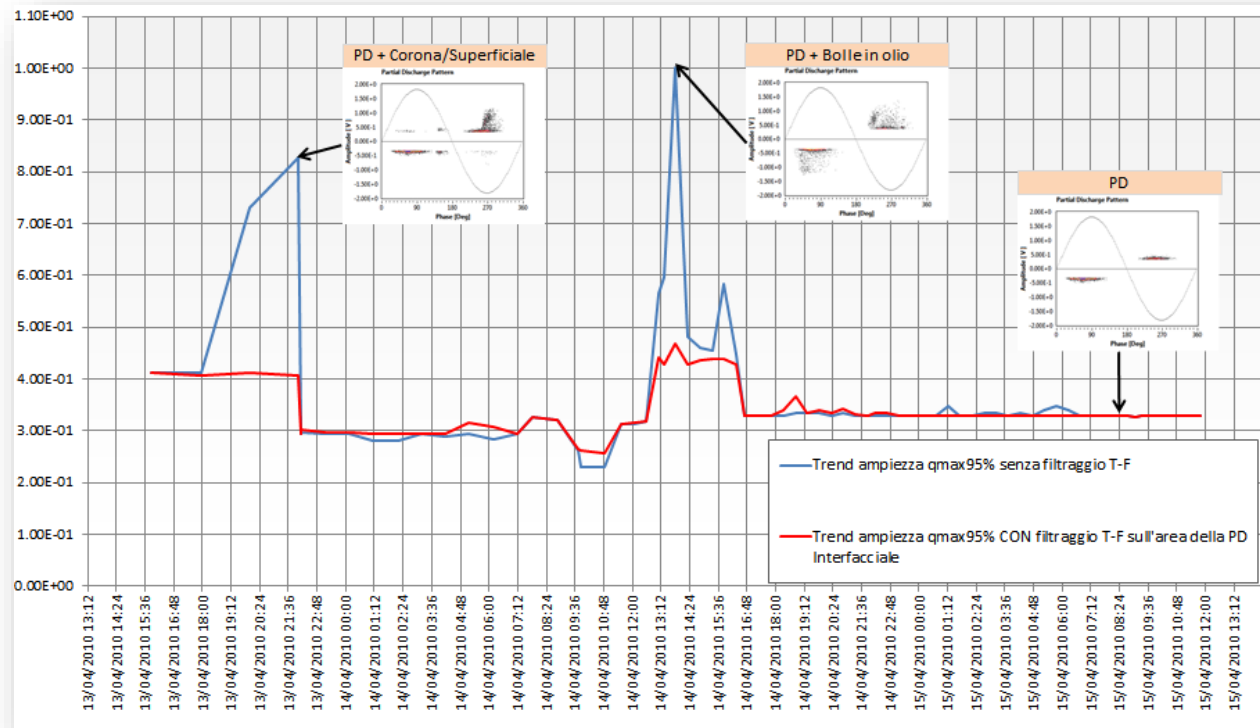
Effectiveness of monitoring: possibility to get alerts about only dangerous phenomenon rather than the maximum amplitude detected.

SEPARATION OF PHENOMENA AND NOISE REJECTION

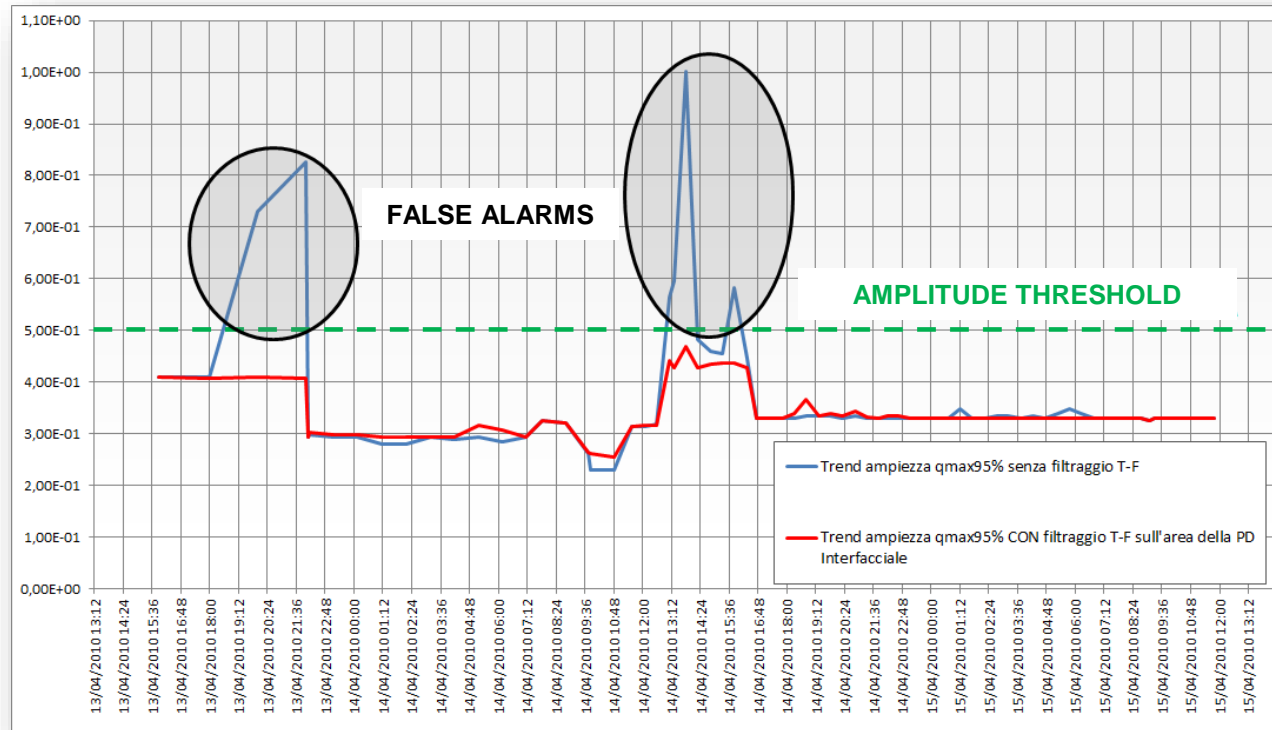
Effectiveness of monitoring: possibility to get alerts about only dangerous phenomenon rather than the maximum amplitude detected.

Possibility of avoiding **FALSE ALARMS**, acting on the amplitude and on trend of moving average of acquisitions.

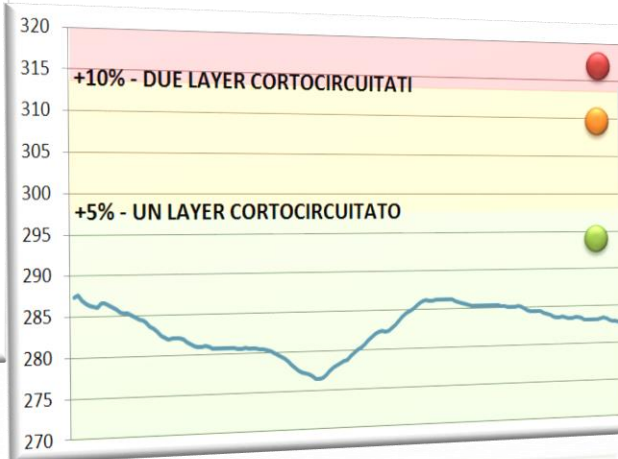
Capacity

- No significant changes in bushing Tan- δ values were noted over the monitoring period (6 months) highlighting that there are **no problems inside the bushings**.
- The H₂ gas levels increased during the monitoring period with rates around 30 ppm/day highlighting that there is a problem **inside the transformer**.
